FIELD INSPECTION REPORT

Project Name:	Mountain Valley Pipeline	Inspector:	Matthew Grant
Inspection Date:	Wednesday, July 8, 2020	Project Contact:	Brian Clauto
Spread G: Giles Montgomery	AR GI-234 AR GI 241.01 MP 202 MP 205-206 ATWS 1333, 1332, 1360	Weather:	Dry

FIELD INSPECTION PHOTO LOG

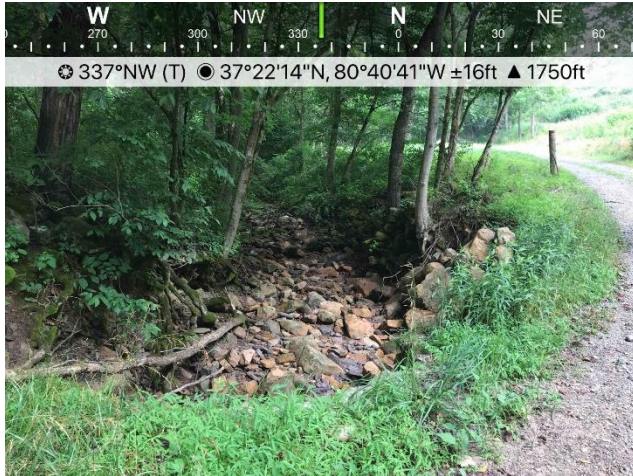
Figure 1: Designated stream S-Q14 along GI 234.

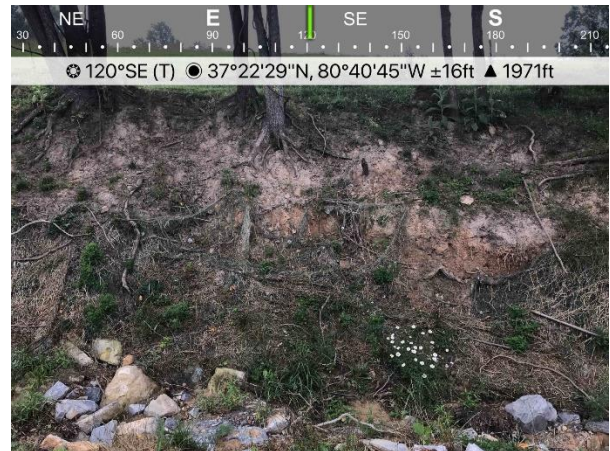
- Ditch line of GI-234 requires repair of matting.

Figure 2: On access rd. GI-234, the ditch line blanket matting requires repair.

Recommended Corrective Action: Maintain and install all controls per the approved PSS&S.

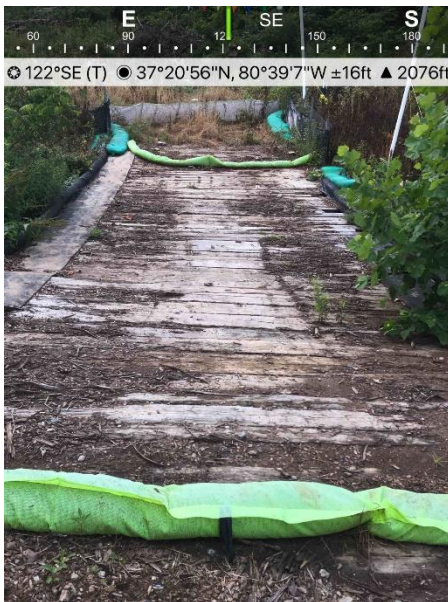
Figure 3: Designated crossing S-G32, ECDs are in place and functioning.

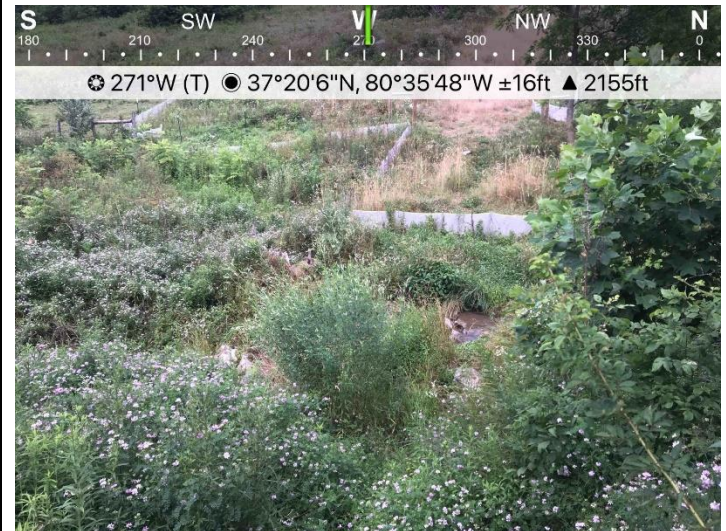
Figure 4: Designated stream S-A32, ECDs are in place and functioning.
